# Resolution of an Orbital Issue: A Designed Experiment

Lisa Huccdleston
NASA KSC

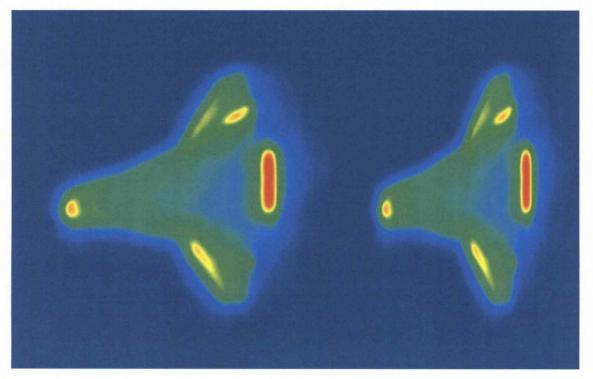
#### **On-orbit issue**

What was the issue?

Who cares if a hunk of ceramic sticks up?

There was extreme interest in not allowing this to happen again...so we used a designed experiment to determine the best way to address it......

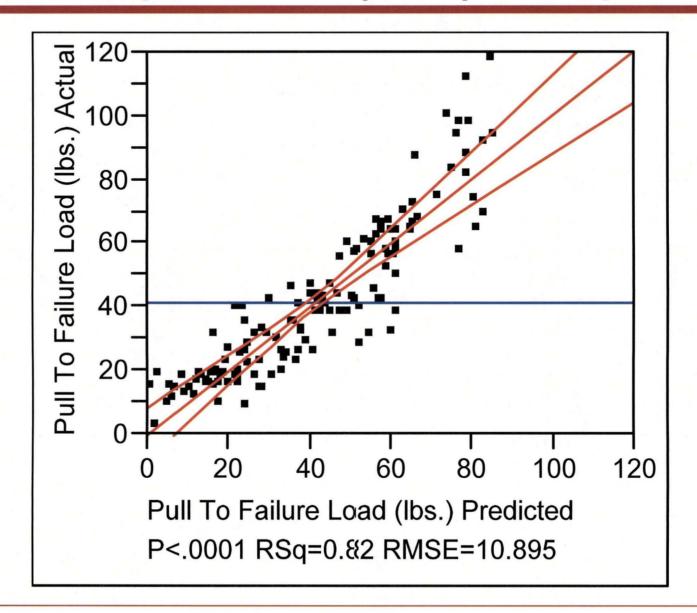
#### **Qualification Test Results**

Ordinary Least Squares Regression was performed on the 142 data points to predict and hypothesize on the effects that the gap filler process improvements may have brought to gap filler bonding at KSC

Source	Nparm	DF	Sum of Squares	F Ratio	Prob > F	Rank
Technician	5	5	1152.939	1.9425	0.0917	3
QC	1	1	107.005	0.9014	0.3442	4
Length (in.)	1	1	54580.025	459.7903	<.0001	1
Ply	5	4	9198.389	19.3722	<.0001	1
Panel (0 = flat, 1 = curved)	1	0	0.000	NA	NA	NA
Complete or Nominal? (0 = nominal, 1 = complete)	1	1	1.983	0.0167	0.8974	5

The smaller the number the less likely the observed effect occurred by chance.

- Ply, and length have the greatest effect on the pull to failure load.
- Fill type (complete or nominal), technician, or QC do not have as great an effect.
- The effect of the panel could not be statistically determined since ply and panel type were not independent. However, examination of the following figures indicates that IML curvature does have an effect on bond strength.
- The following is the overall summary of the 142 data points:

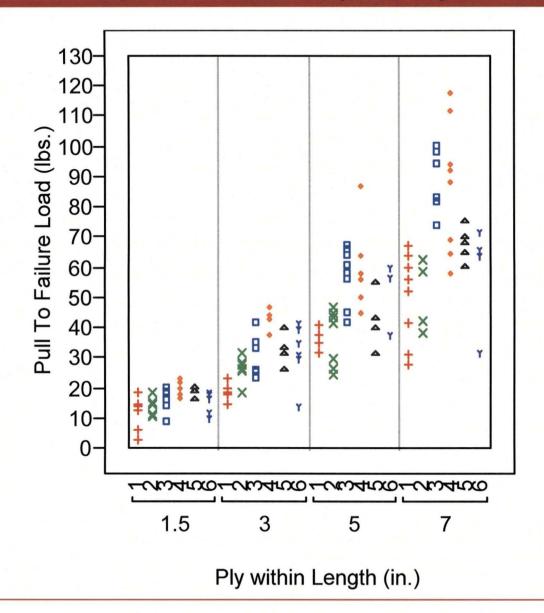
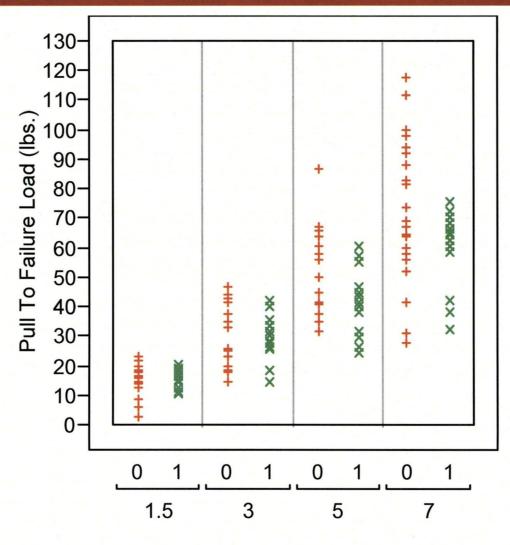
Panel (0 = flat, 1 = curved) within Length (in.

- New process allows for an average gap filler pull to failure value of 41 lbs.
  - Range of pull to failure values range from 3 lbs. To 118 lbs.
- Length and to a lesser degree, ply, have the greatest effect on the pull to failure load
  - Curved or flat panel effect cannot be determined statistically but from observation of trend on previous charts, IML curvature does seem to have an effect on bond strength.
